Natural Bed of Masonry Stones and Its Effect on the Stability of Wall Stucco Decoration in Historical Buildings

Mohamed Ali house was built at the period between 1882 and 1914, when crescent and Pentagonal star decorations prevailed, that represents the Egyptian flag in this period [1], and it's the main stucco decoration element in the house façade. limestone used for building up from nearby quarries (Mokattam quarries) at Cairo. In terms of mineralogy and structure, stone is an extremely complex material - a complexity is reflected in its weathering response to stone natural and the building environment. [2], The decay of materials is a function of intrinsic and extrinsic factors. The intrinsic factors are related to the material itself, and include the type of the material, its properties and its microstructure. The extrinsic factors refer to the effect that the environment has on the material and can be generally divided into factors related to the atmosphere and factors related to the usage of the material respectively. [3], Moisture and salt decay processes are amongst the most

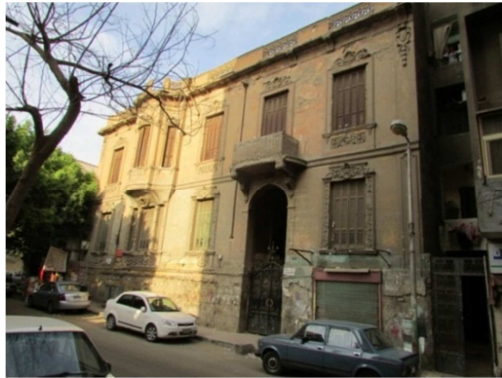
Figure 1. Show the general view of the building (Mohamed Ali house) Decorated with stucco ornaments.

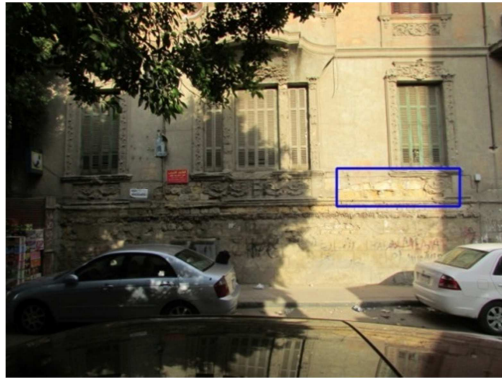
Figure 2. Show Inside the blue rectangle stucco decorations Separated from the wall.

The main problem is stucco decoration separation from the wall (substrate), this problem resulting from incorrect building stone position not being perpendicular to Bedding Plane of the stone blocks, it's kind of deterioration intrinsic factors The natural bed of stone indicates the plane or bed on which the sedimentary stone was originally deposited. Fig. 9. that made stones blocks very weak to bearing, Because of wall loads and

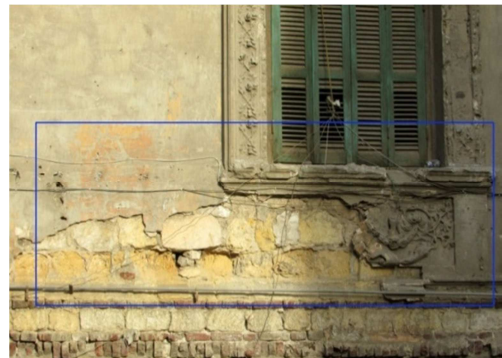
Figure 3. Details of the previous fig shows the stones course that were built on incorrect Natural Bed.

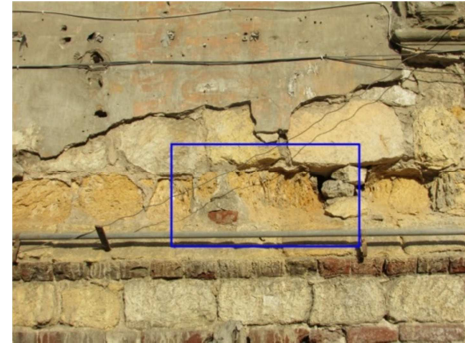
Figure 4. Details of the previous fig shows one of the building stone that have Exfoliation.

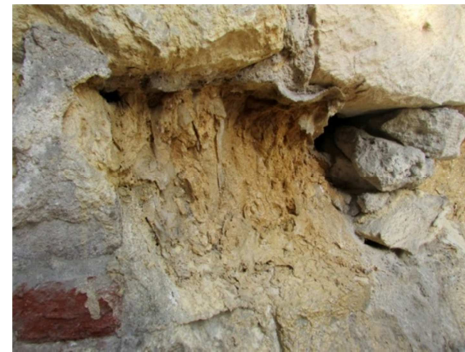
Figure 5. Show Exfoliation, efflorescence of salts.

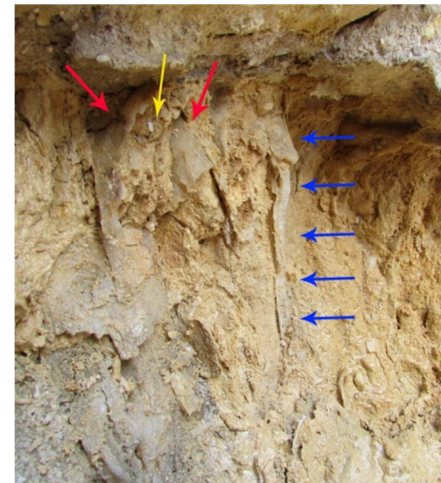
Figure 6. Shows Blue arrows represent efflorescence of salts Longitudinally, Red and yellow arrows illustrate the Sequence of sediment layers of stone and Longitudinally salt efflorescence.

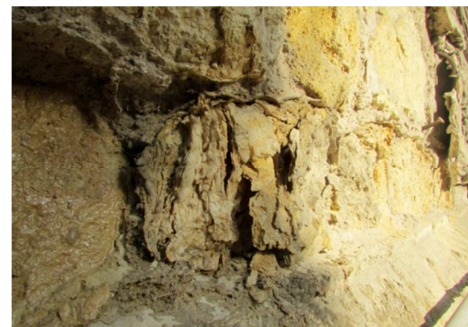
Figure 7. Shows the longitudinally separation of sedimentation layers According to Bedding Plane.

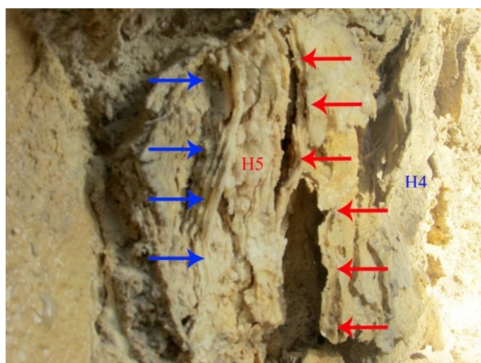
Figure 8. Blue and red arrows shows The longitudinally separation of sedimentation layers According to Bedding Plane As a result of the pressure force caused by salt crystallization longitudinally, H4: Place of fallen stone sample, H5: a sample from efflorescence of salts Longitudinally According to Bedding Plane.

Stone sample were taken from the deteriorated stone at the middle of the house façade, salt efflorescence were sampled from stone bedding plane. samples list is shown in Table 1 and samples location in the wall in Figure 8. Stone and salt samples were studied with an X-ray diffraction Technique were used to study stone and salt mineralogy using a panalytical X-Ray Diffraction equipment model X, Pert PRO at 40 kV and 30 mA with a Cu source anode. and Micro-XRF were used to study stone and salt elements using C N S I (Micro-XRF) Orbis Micro X-ray Fluorescence (Micro-XRF) Analyzer.

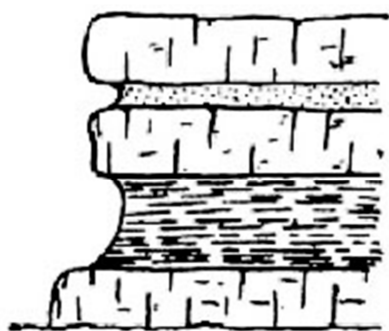
Figure 9. Show Horizontal bedding of sedimentary rocks. [8].

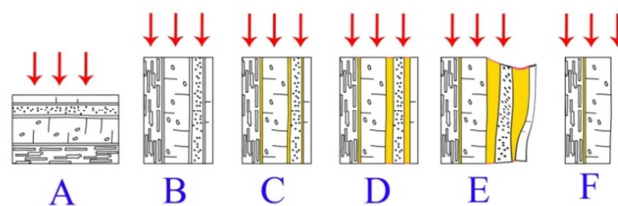
Figure 10. Show red arrows indicate loads located on the Stones, A: Correct position for building stone Loads perpendicular to the Horizontal bedding of stone, B: incorrect position for building stone, C: salt crystal growth in Bedding Plane with yellow color, D: Overgrowth of salt crystal, E: The collapse of the outer layers, F: Exfoliation happen.

either through the calculation of crystallization pressure, rock tensile strengths fluctuate between 2 and 20 Mpa [13], Crystal growth gives rise to crystallization pressure. For instance, the crystallization pressure of halite, is about 65 Mpa [14], the big difference between rock tensile strengths and the crystallization pressure of halite led to stone deterioration. so Salt crystallization pressure is responsible for physical weathering of the stone. [15], when thermal expansion coefficient of a salt exceeds the surrounding rock, then the conditions are set for physical weathering to occur. The thermal expansion coefficient for halite is four times larger than for calcite. temperature changes can also produce stresses within the rocks. The fabric decay by salt loading is accompanied by micro cracking. which result in a permanent increase in volume. [16], Finally Exfoliation happen, Exfoliation used to describe natural stone deterioration it most often occurs along natural bedding planes, resulting in an unevenly layered surface. Incorrectly laid stones with their bedding plane laid up parallel or perpendicular to the surface of the building thus have a natural tendency to exfoliate faster, following the lines of the bedding planes. [17], Fig. 10. B-F so Exfoliation is one of the most important kinds of stone weathering.

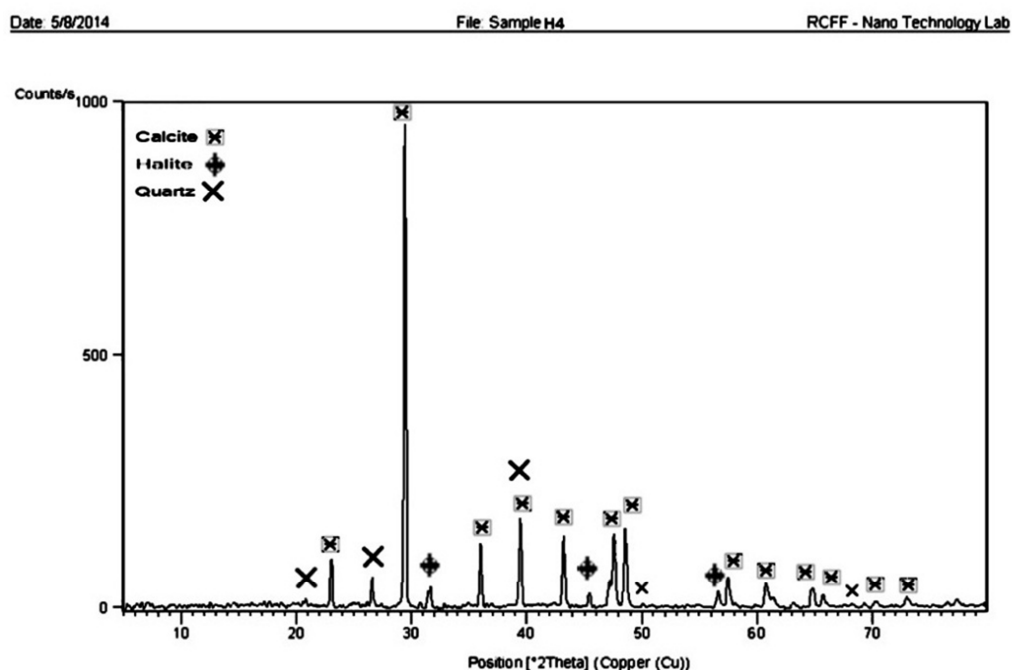
Figure 11. Shows X-ray diffraction pattern of the sample H4.

X-ray diffraction pattern of the sample H4 give the proportions of the stone component, Calcite the main component 89.14%, Halite 5.56% and Quartz 5.29%

limestone used in construction as a support for stucco decoration, calcite proportion nearly 90%, halite considered extraneous component due to the deterioration of the wall which means that the percentage of calcite exceed to 93%, quartz more than 5% in this case it consider the binder of calcite Crystals in limestone Fig. 11. the limestone has a small percentage of two salt halite and sylvite commonly found in Egyptian soil. stone yellowish color due to the presence of small proportion of iron and aluminum oxides. Table.2. Sodium chloride is most expected to be formed in the building materials due to its high solubility [9], halite salt is the main salt because chlorine and sodium ions which form the ratio exceed 98% There are some other ions such as potassium is an indicator for the presence of sylvite Salt Kcl. the two salts commonly merged in the Egyptian soil. there are some other ions such as iron, aluminum, silicon and calcium presence of such ions with the salts as a result of ions displaced between salt and stone. Fig. 14, Table. 3. so Stone deterioration caused by salt efflorescence. it is easy to observe and locate the natural bed as it lies along the plane of stratification. The natural bed can occur in case of only sedimentary type of rocks as our lime stone. In stone masonry, the direction of natural bed of all sedimentary stones should be perpendicular to the direction of pressure. Fig. 10. A Stone set in a building with its grain running horizontally, as it does in the quarry, is said to be set on its "natural bed" [10]. This arrangement ensures maximum strength of stone work. if it doesn't set on its "natural bed" The stone can easily split along this plane. [11], the split due to pressure from the wall loads and salt crystals growth in the Bedding Plane Fig. 10. B-F. Hydration, crystallization, and thermal expansion are additional types of expansionary force that are believed to cause rock failure. Such stress concentration effects contribute to crack growth from randomly oriented micro cracks inducing further damage and reducing the rock strength. [12], The assessment of the susceptibility of stone to salt decay can be accomplished

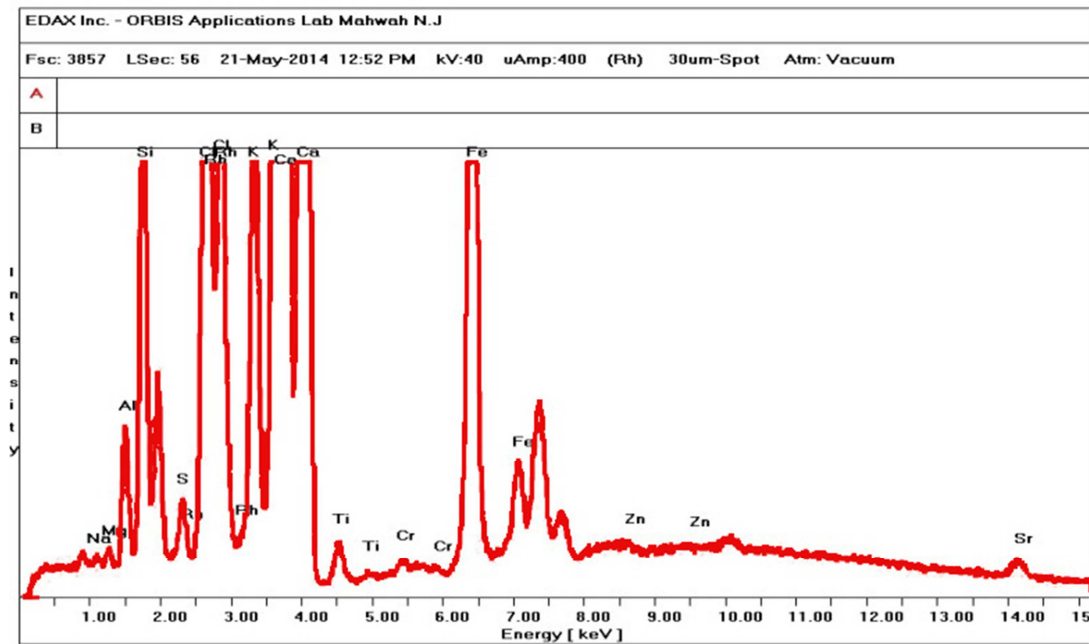
Figure 12. Shows (Micro-XRF) pattern of the sample H4.

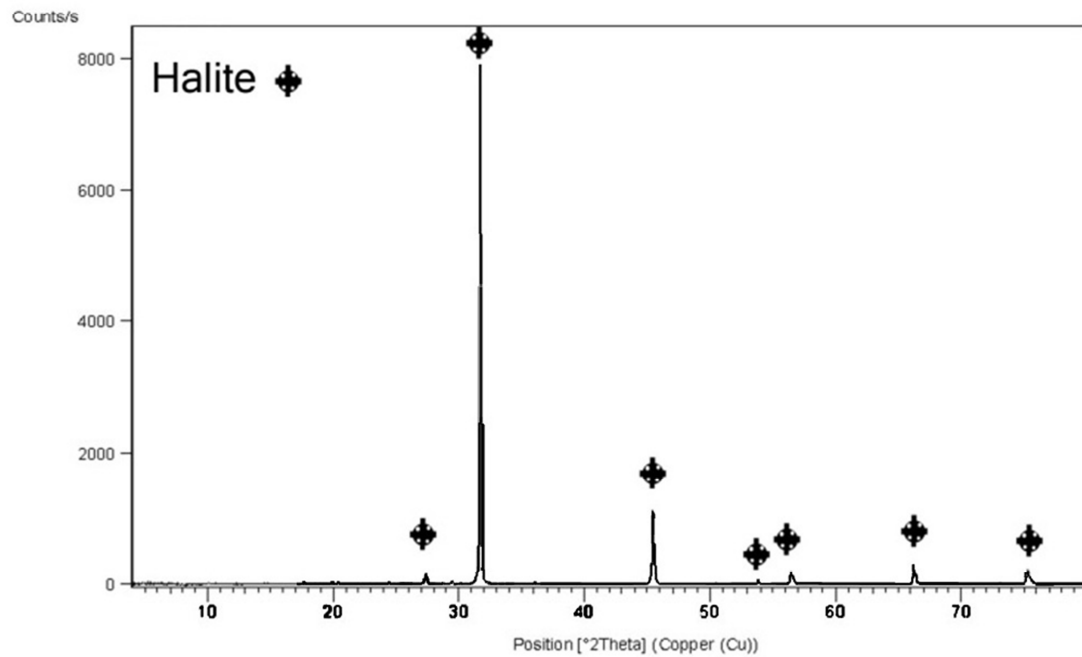
Figure 13. Shows X-ray diffraction pattern of the sample H5.

X-ray diffraction pattern of the sample H5 give a main component halite salt.

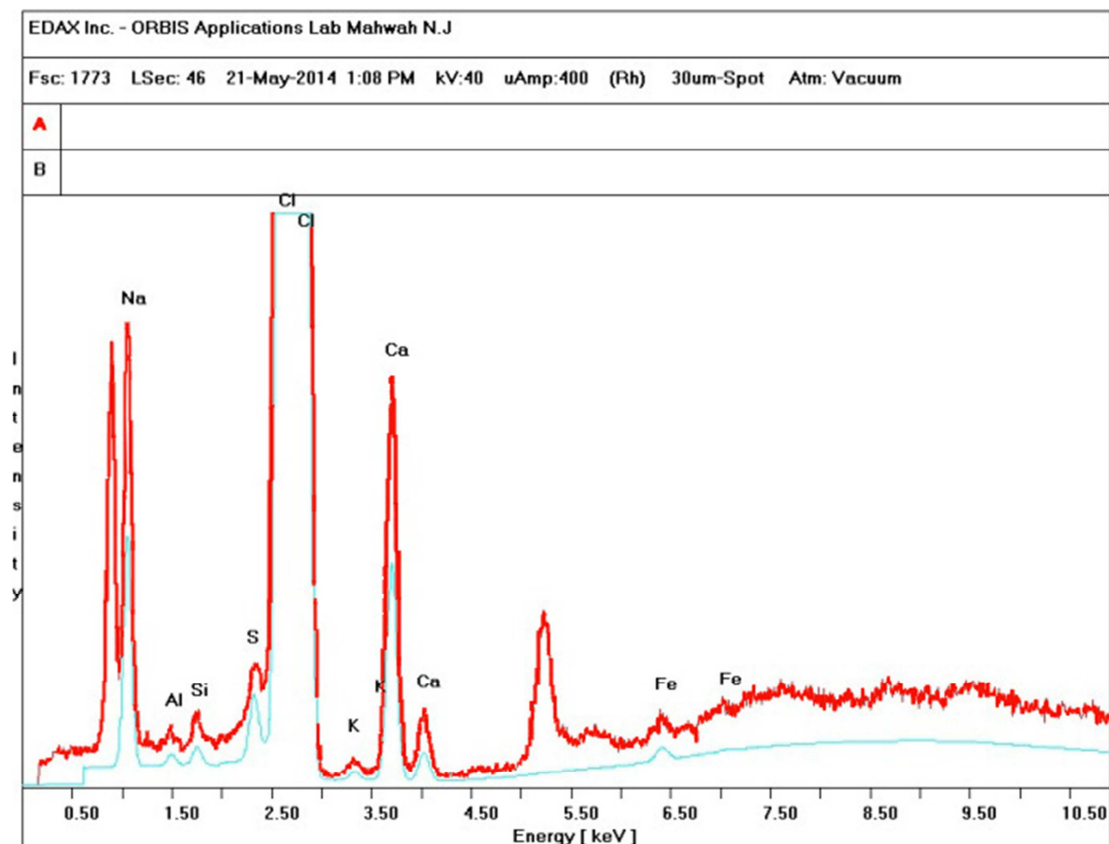
Figure 14. Shows (Micro-XRF) pattern of the sample H5.
